Attachment Challenges in Compromised Situations

Functionality and esthetically pleasing results driven by dental team communication.

By Dennis Urban, CDT

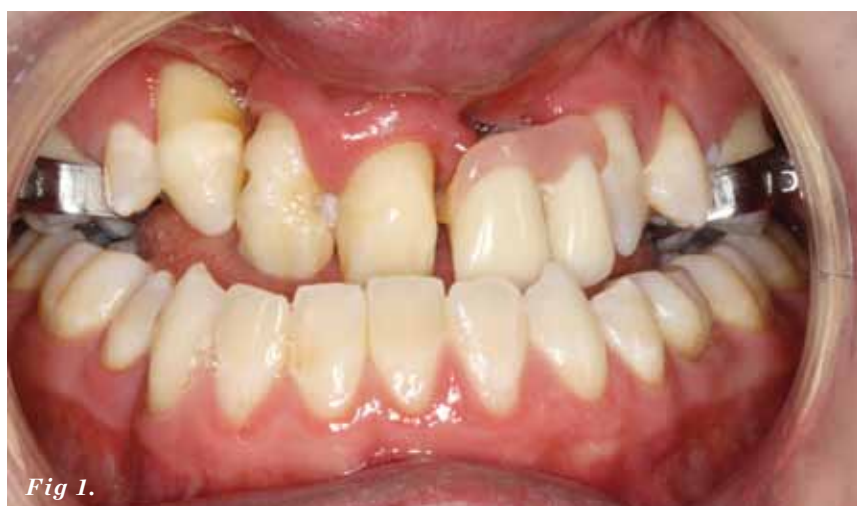
Fig 1. An orthodontic wire-retained prosthesis.

Based on photographs and the study models, the case seemed odd; in addition to having malocclusion, it appeared that the patient had some type of deformity on the palate and alveolar ridge. The patient was also wearing an orthodontic wire-retained prosthesis with some anterior denture teeth attached to it (Figure 1 and Figure 2). From the meeting with Dr. Merrill and his associates at their office, it was apparent

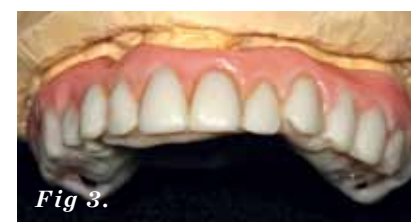
Fig 3. An acetal resin appliance after 6 months of wear.

This type of prosthesis would be both kind to natural dentition and also prove to be functional. However, long-term retention was a concern. The photograph in Figure 3 shows the appliance after 6 months of wear. The appliance functioned well—in fact, better than was expected—but to devise a long-term solution, the team needed a type of attachment for an overdenture type case scenario. As implants were out of the question, the dental team created a low-profile attachment in which the doctor would use natural dentition with a post and core. Their solution and correct choice was Rhein83's low-profile OT Equator attachments.

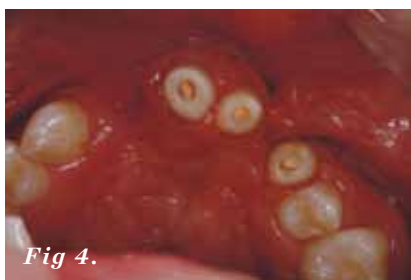
Fig 4. The post and core sites were prepared.

First the sites for the post and core copings were prepared (Figure 4), and an impression was sent to the laboratory (Figure 5). After the model work was finished (Figure 6), the technician waxed up the copings with castable equator patterns attached to the copings (Figure 7). The copings were cast and finished (Figure 8). At this point, both the impression copings and the Equator metal housing with inserts were ready to be sent to Dr. Merrill (Figure 9).

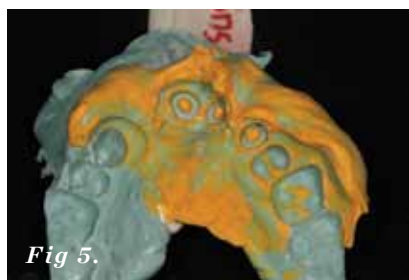
Fig 5. Impression of the prepared sites.

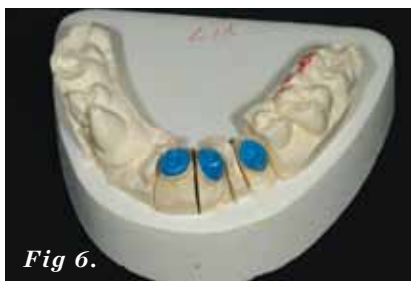
Fig 6. The finished model work.

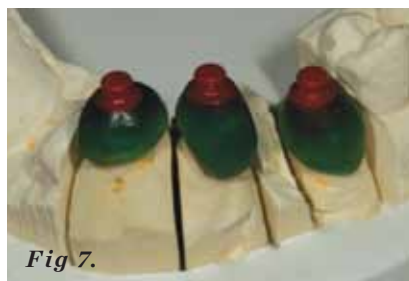
Fig 7. Waxed up copings with Equator patterns.

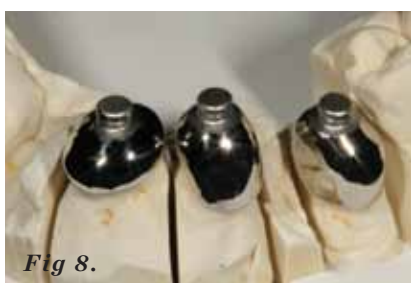
Fig 8. Finished and polished copings.

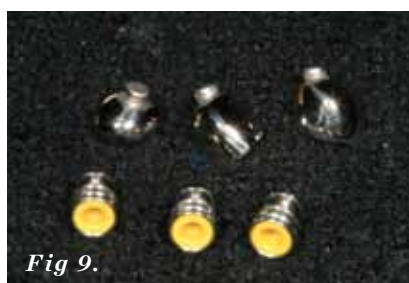
Fig 9. Post, core, and impression copings.

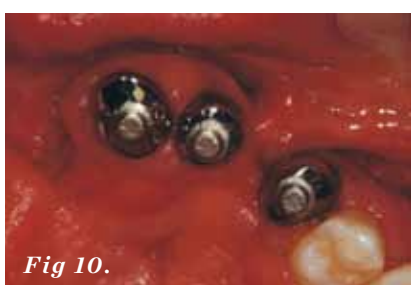
Fig 10. The Equator copings were cemented in place.

Next, the post and core copings were cemented, the impression coping was placed, and an impression was taken (Figure 10 through Figure 12). The impression was then loaded with Equator analogs and poured (Figure 13). The final models were mounted on an Artex articulator using a face-bow (Figure 14). This ensured that the prosthesis would be made exactly to the patient's cranium/axis relationship.

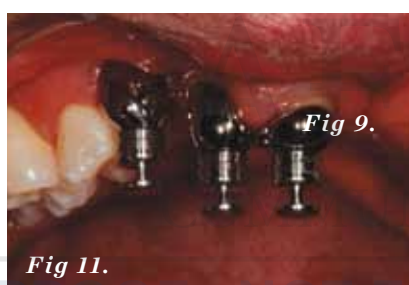
Fig 11. The Equator impression copings were ready to be picked up in the impression.

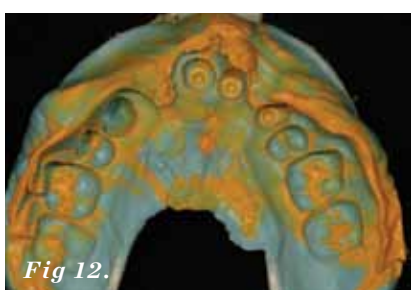
Fig 12. The final impression with impression copings.

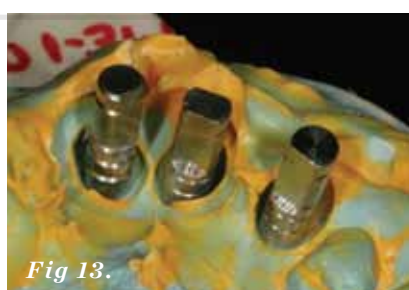
Fig 13. The impression was loaded with Equator analogs.

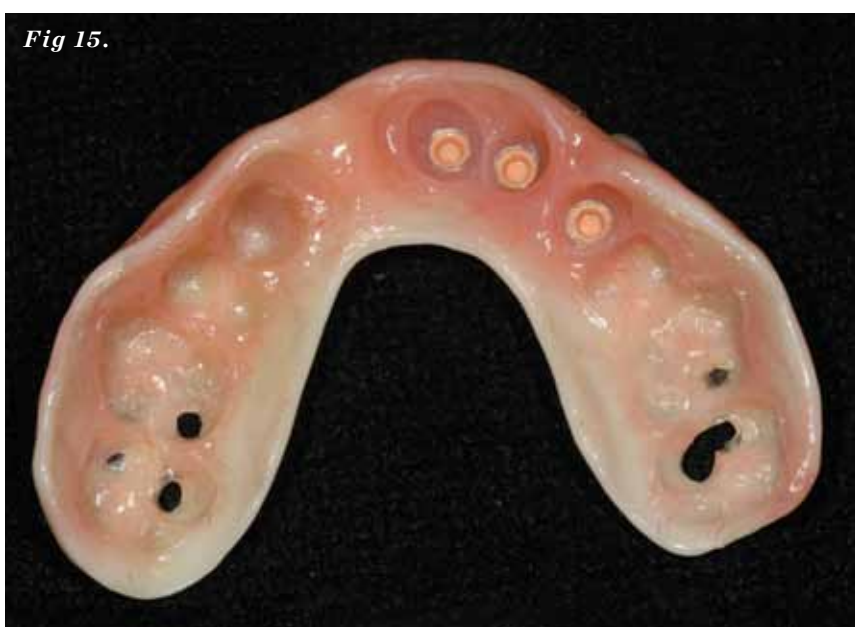
Fig 15. Acetal resin appliance with Equator housings was picked up in reline impression.

Dr. Merrill wanted to convert the original temporary appliance to a Rhein83 Equator-retained partial to be used as a spare and also to be worn while a new, more esthetic partial was being made. To do this, the doctor picked up the Equator housings and inserts in a reline impression. The team then

relined the appliance and processed the Equator attachments at the laboratory. (Figure 15).

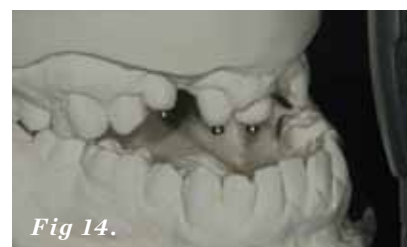
Fig 14. The models were mounted using the face-bow transfer.

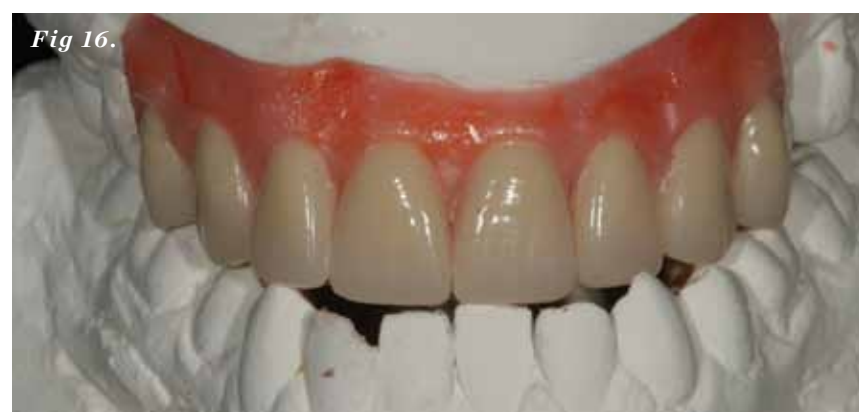
Fig 16. The waxed denture was prepared for the patient and doctor's approval

The dental team is in the process of making a much more esthetic final restoration. Part 2 of this article will show photographs of the outcome. The final restoration will be a combination of an acetal resin framework with overlays on some of the posterior teeth to compensate for the malocclusion, and Ivoclar Vivadent denture teeth will be used to create more natural-looking esthetics. Figure 16 shows the waxed-up appliance (Figure 16).
