Unique Approach to a Difficult Case

Rhein83 uses CAD technology to repair an implant-retained denture case.

By T.G. Hornisher, CDT

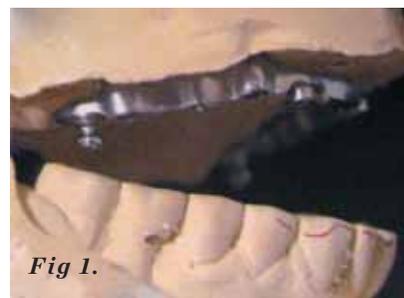
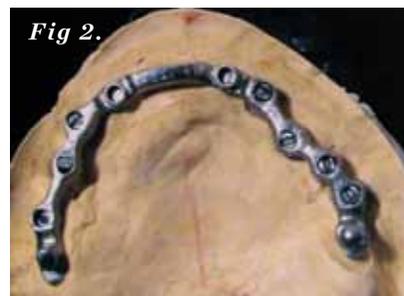
Fig 1. and Fig 2. The difficulties in the implant bar case centered on unidentified implants and a worn implant bar cast from an unidentified alloy.

In a 2004 article¹ that involved an implant bar case (Figure 1 and Figure 2), the difficulties centered on unidentified implants and a worn implant bar cast from an unidentified alloy. At that time, the chosen solution was to re-mill the bar, cast spherical attachments and phaser weld to this mystery bar. This solution worked for several years, although the patient experienced some breakage as the denture teeth wore down. When the time approached for refurbishing the implant-retained denture, the patient chose to find a new restoring dentist and explore other alternatives that would present fewer problems.

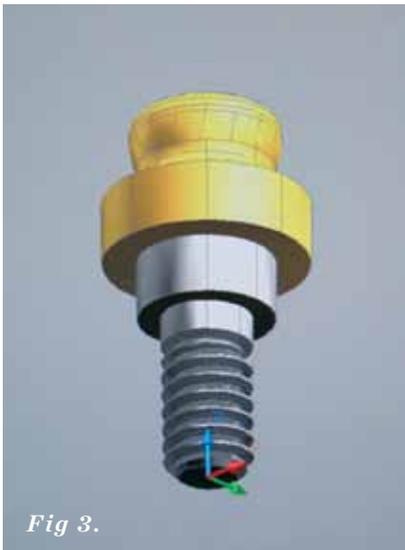
Fig 3. The case was scanned at the Rhein83 facility in Italy, and they attempted to CAD/CAM mill the Rhein83 Equator abutments. Using CAD technology, Rhein83 configured the actual retentive portion of the attachment.

After many inquiries, the technician received a call from Rhein83 USA with a solution. The model would be shipped to the Rhein83 facility in Italy. There they would scan the case and attempt to CAD/CAM mill the Rhein83 Equator abutments (www.rhein83usa.com) to match the unidentified implant thread pitch and length.

configured the actual retentive portion of the attachment (Figure 3). The case was milled and the custom abutment was completed (Figure 4). These are the shortest stud type of their class. Initially only four abutments were milled. Later, the restoring team decided that two more were needed. Using the same CAD-stored data file, Rhein83 milled two more. The custom abutments were delivered and an impression was taken (Figure 5).

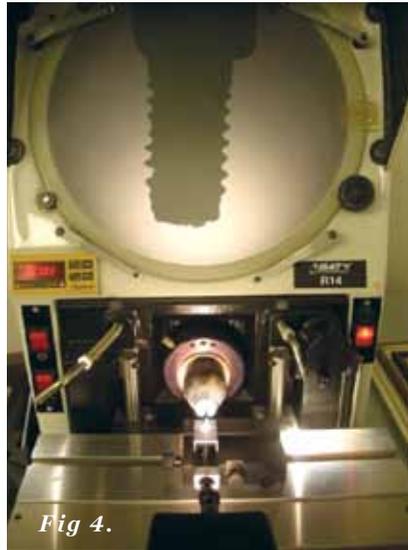
Fig 4. The case was milled and the custom abutment was completed.

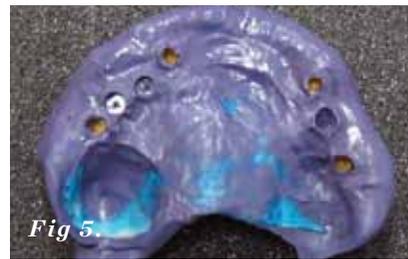
Fig 5. The custom abutments were delivered and an impression was taken.

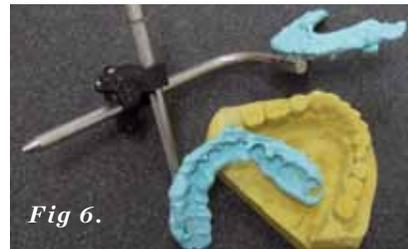
Fig 6. The case was facebow-mounted on a Denar Combi articulator and set up using the principles of replicating the anterior esthetics with lingualized posterior occlusion

Prior to this, the restoring team was able to customize three cover screws. The case was then facebow-mounted on a Denar Combi articulator (Whip Mix Corp, www.whipmix.com) and set up using the principles of replicating the anterior esthetics with lingualized posterior occlusion (Figure 6). This posterior occlusal scheme is extremely important, particularly with implant cases.

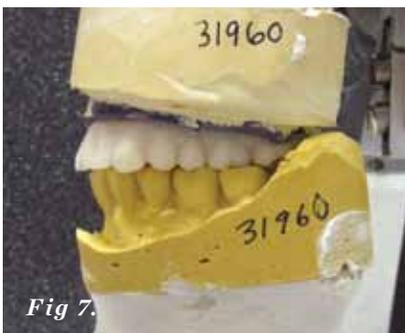
Fig 7. Lingualized occlusion was recommended for the restoration of this full-arch dental implant case.

Since it was understood that mutually protected occlusion is difficult and time-consuming to fabricate, fit, and maintain, alternative occlusal schemes were suggested. Lingualized occlusion was recommended for the restoration of this full-arch dental implant case (Figure 7). The objectives of lingualized occlusion are the same, but offer the major benefits of the ease with which it can be established and maintained as well as the ability to direct occlusal loads axially onto the supporting dental implants.

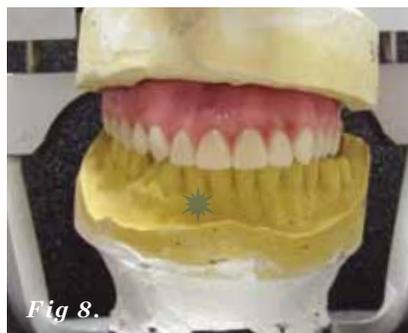
Fig 8. Implants do very well with vertical loads, but perform poorly with continued lateral stresses.

the potential for lateral interferences in excursive movements.² In short, implants do very well with vertical loads, but perform poorly with continued lateral stresses (Figure 8).

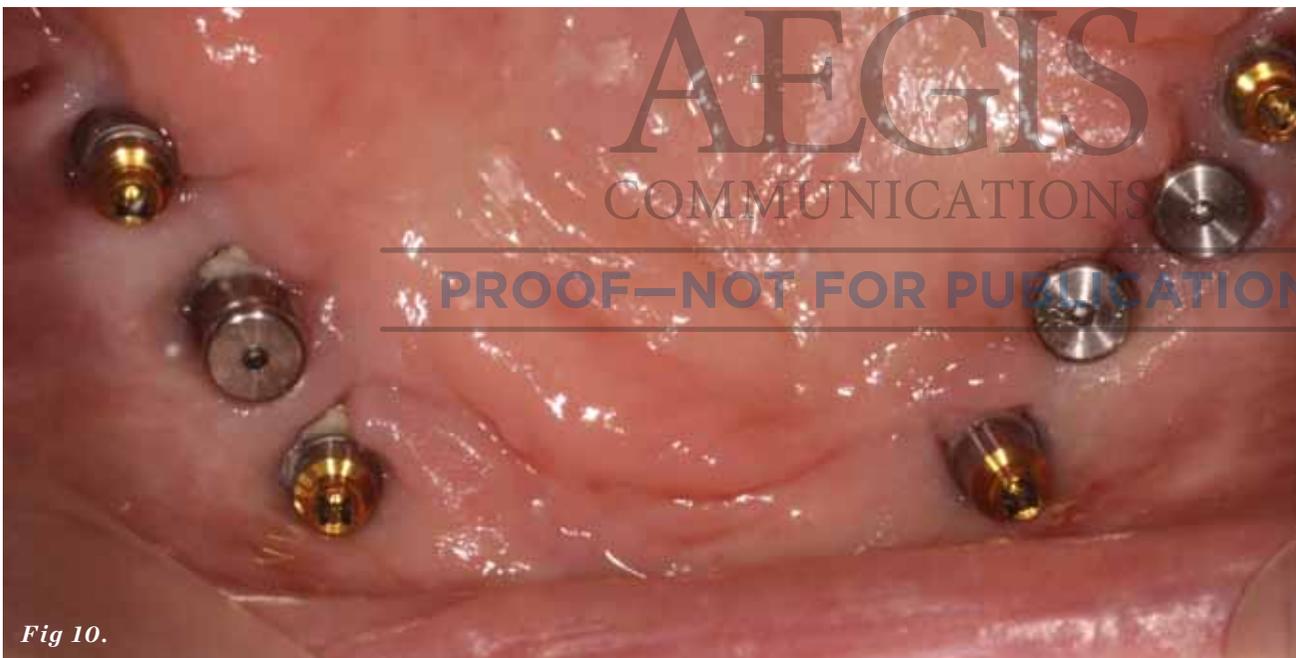
Fig 10. Intraoral placement of equators

The Equator abutments (Figure 10) come with a series of retentive caps. The pink caps were used in this case because four attachments were to be activated (Figure 11). Figure 12 and Figure 13 show the before and after images of this case.

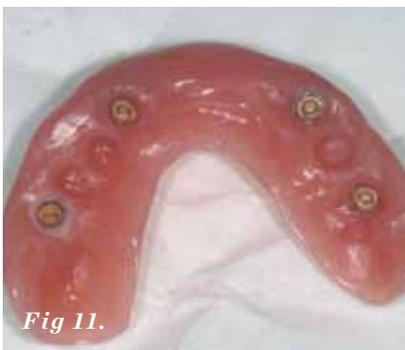
Fig 11. The pink caps were used in this case because four attachments were to be activated.

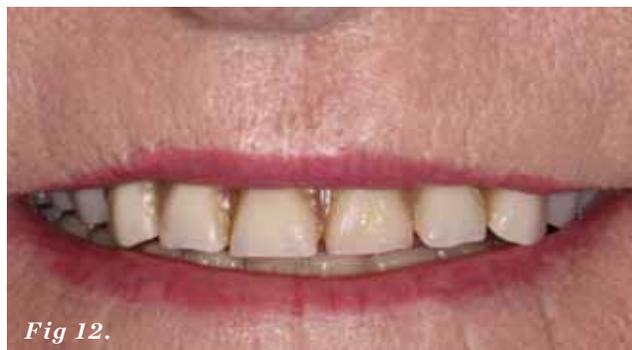
Fig 12. A view of the patient's smile before.

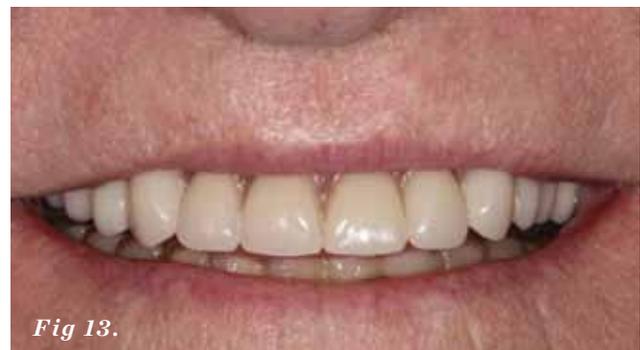
Fig 13. A view of the patient's smile after.
