## Unique Approach to a Difficult Case

Rhein83 uses CAD technology to repair an implant-retained denture case.

By T.G. Hornisher, CDT

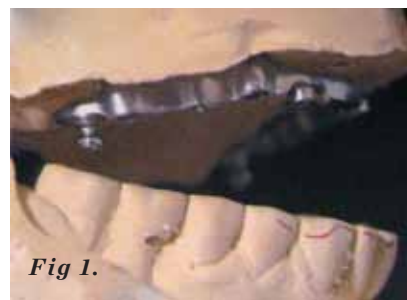
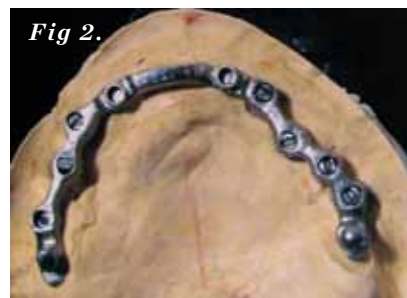
Fig 1.

**Fig 1. and Fig 2.** The difficulties in the implant bar case centered on unidentified implants and a worn implant bar cast from an unidentified alloy.

In a 2004 article<sup>1</sup> that involved an implant bar case (Figure 1 and Figure 2), the difficulties centered on unidentified implants and a worn implant bar cast from an unidentified alloy. At that time, the chosen solution was to re-mill the bar, cast spherical attachments and phaser weld to this mystery bar. This solution worked for several years, although the patient experienced some breakage as the denture teeth wore down. When the time approached for refurbishing the implant-retained denture, the patient chose to find a new restoring dentist and explore other alternatives that would present fewer problems.

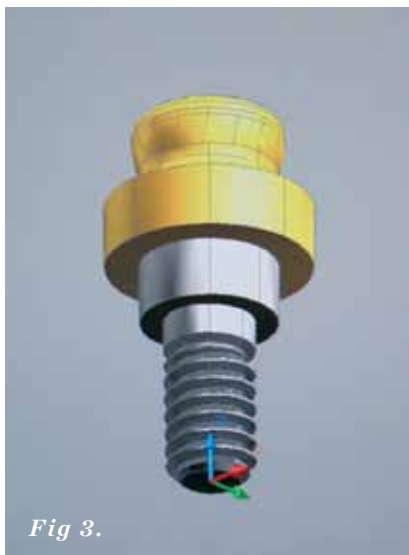
Fig 3.

**Fig 3.** The case was scanned at the Rhein83 facility in Italy, and they attempted to CAD/CAM mill the Rhein83 Equator abutments. Using CAD technology, Rhein83 configured the actual retentive portion of the attachment.

After many inquiries, the technician received a call from Rhein83 USA with a solution. The model would be shipped to the Rhein83 facility in Italy. There they would scan the case and attempt to CAD/CAM mill the Rhein83 Equator abutments ([www.rhein83usa.com](http://www.rhein83usa.com)) to match the unidentified implant thread pitch and length.

configured the actual retentive portion of the attachment (Figure 3). The case was milled and the custom abutment was completed (Figure 4). These are the shortest stud type of their class. Initially only four abutments were milled. Later, the restoring team decided that two more were needed. Using the same CAD-stored data file, Rhein83 milled two more. The custom abutments were delivered and an impression was taken (Figure 5).

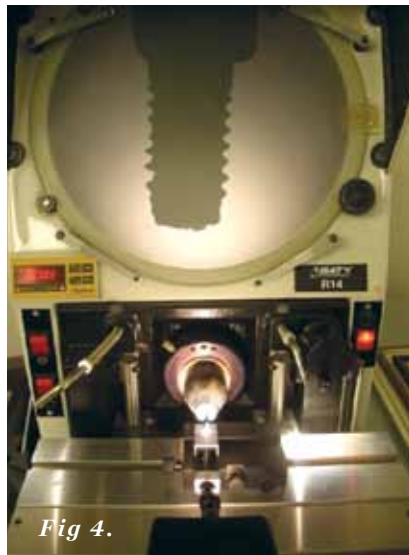
Fig 4.

**Fig 4.** The case was milled and the custom abutment was completed.

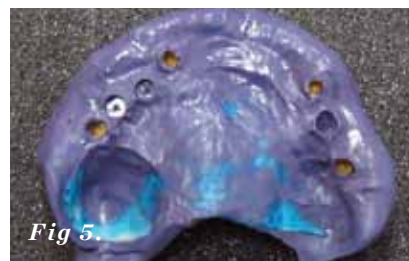
Fig 5.

**Fig 5.** The custom abutments were delivered and an impression was taken.

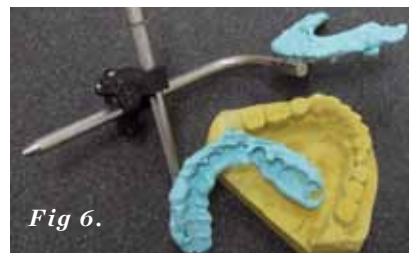
Fig 6.

**Fig 6.** The case was facebow-mounted on a Denar Combi articulator and set up using the principles of replicating the anterior esthetics with lingualized posterior occlusion

Prior to this, the restoring team was able to customize three cover screws. The case was then facebow-mounted on a Denar Combi articulator (Whip Mix Corp, [www.whipmix.com](http://www.whipmix.com)) and set up using the principles of replicating the anterior esthetics with lingualized posterior occlusion (Figure 6). This posterior occlusal scheme is extremely important, particularly with implant cases.

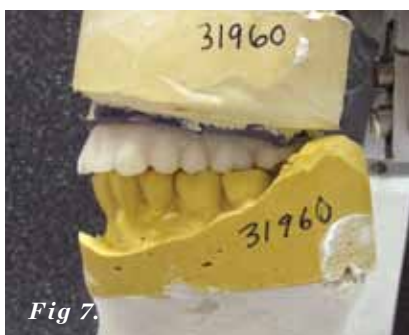
Fig 7.

**Fig 7.** Lingualized occlusion was recommended for the restoration of this full-arch dental implant case.

Since it was understood that mutually protected occlusion is difficult and time-consuming to fabricate, fit, and maintain, alternative occlusal schemes were suggested. Lingualized occlusion was recommended for the restoration of this full-arch dental implant case (Figure 7). The objectives of lingualized occlusion are the same, but offer the major benefits of the ease with which it can be established and maintained as well as the ability to direct occlusal loads axially onto the supporting dental implants.

Lingualized occlusion is the preferred solution for tissue- and implant-borne overdentures. The penetration of the bolus of the food is accomplished with less occlusal force and the opposing incline surfaces of the tooth provide bucco-lingual stability and eliminate

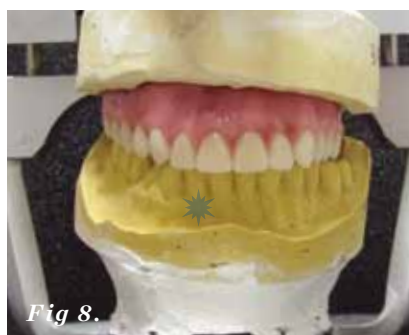
Fig 8.

**Fig 8.** Implants do very well with vertical loads, but perform poorly with continued lateral stresses.

the potential for lateral interferences in excursive movements.<sup>2</sup> In short, implants do very well with vertical loads, but perform poorly with continued lateral stresses (Figure 8).

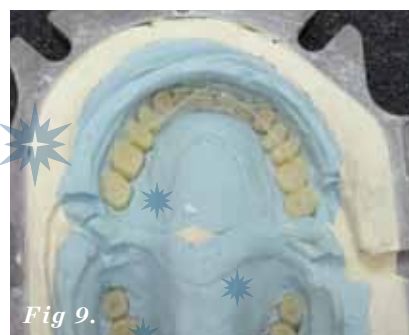
Fig 9.

**Fig 9.** The Duoflask allowed the technician to process two prostheses simultaneously.

After the patient and restoring clinician approved the case, it was flaked using the Palajet® Duoflask (Heraeus Kulzer, [www.heraeus-dental-us.com](http://www.heraeus-dental-us.com)). The Duoflask allowed the technician to process two prostheses simultaneously (Figure 9). Note that the Fiber Bar (Preat Corp, [www.preat.com](http://www.preat.com)) was used in the anterior region to add extra strength to the prosthesis in order to eliminate past issues with breakage. The case was injected with Palajet acrylic (Heraeus Kulzer) for its tissue adaptation qualities and strength. A moderate tinting of the denture base was included, and the attachment caps were processed along with the case.

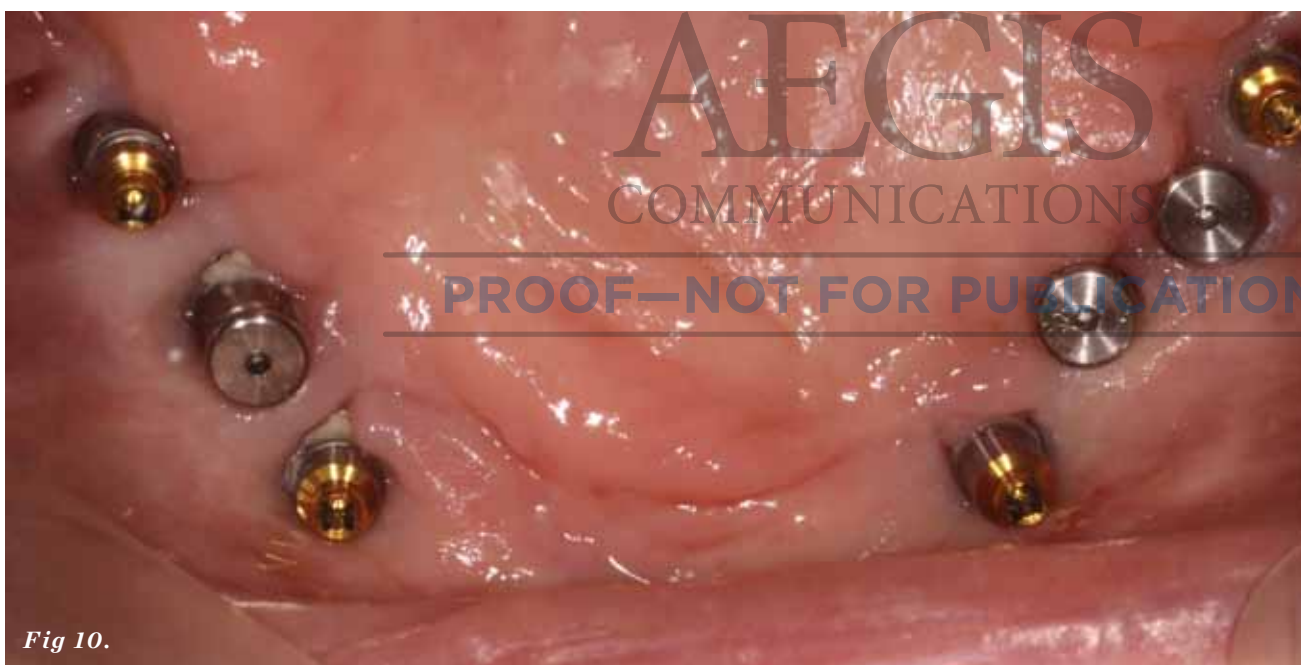
Fig 10.

**Fig 10.** Intraoral placement of equators

The Equator abutments (Figure 10) come with a series of retentive caps. The pink caps were used in this case because four attachments were to be activated (Figure 11). Figure 12 and Figure 13 show the before and after images of this case.

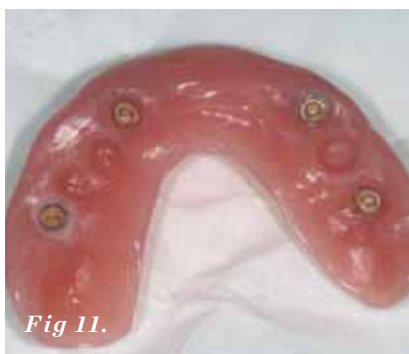
Fig 11.

**Fig 11.** The pink caps were used in this case because four attachments were to be activated.
